A STUDY OF A CYLINDER WALL
MICRO-STRUCTURE

BRUSH RESEARCH MANUFACTURING CO., INC.

EVOLUTION OF A STUDY IN THE MICRO-FINISHING OF CYLINDER WALLS

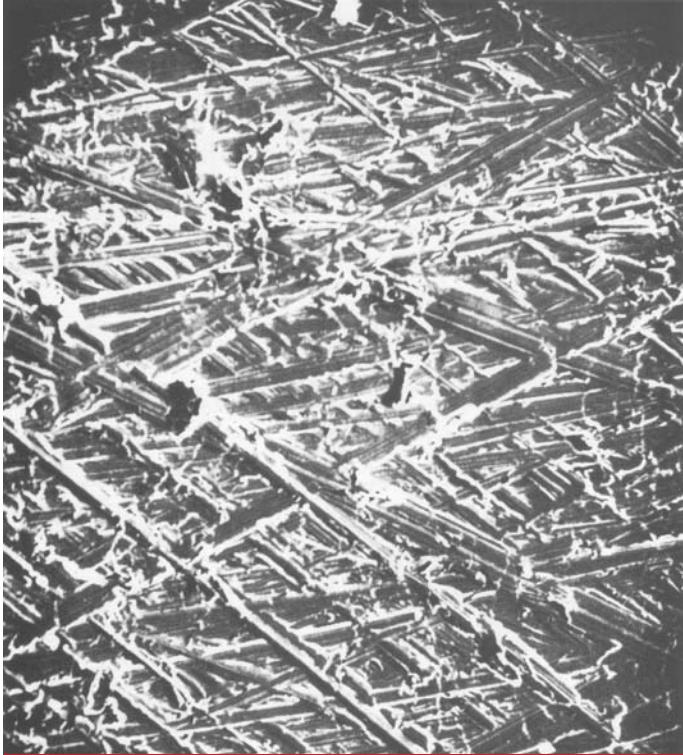
No 6 X200 AE PLATEAU

Left side are sections of the A.E.F. Plateaued Rigid Honed liner. On the Right Side the same sections Flex-Honed with an 80 grain SC.

These are SEM photos of Liner 30202, Plateau-Rigid Honed by A.E.F.

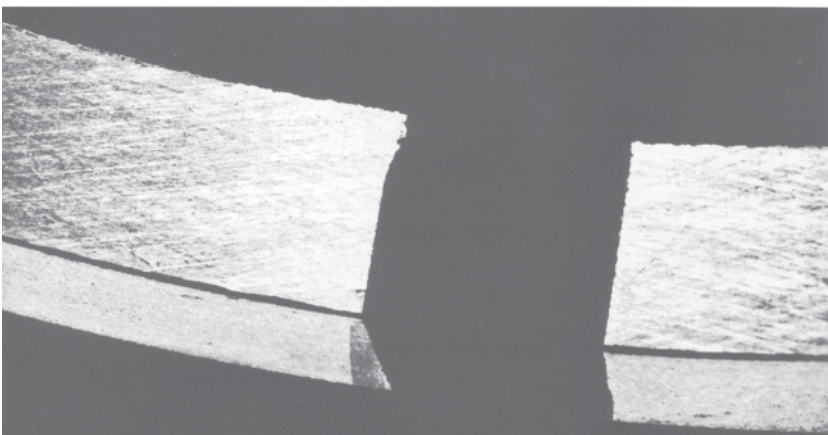
The lower section has been Flex-Honed. The vast difference in the finish and the cross hatch is very evident to the naked eye. Note the over-all consistency is a feature of the Flex-Hone finish.

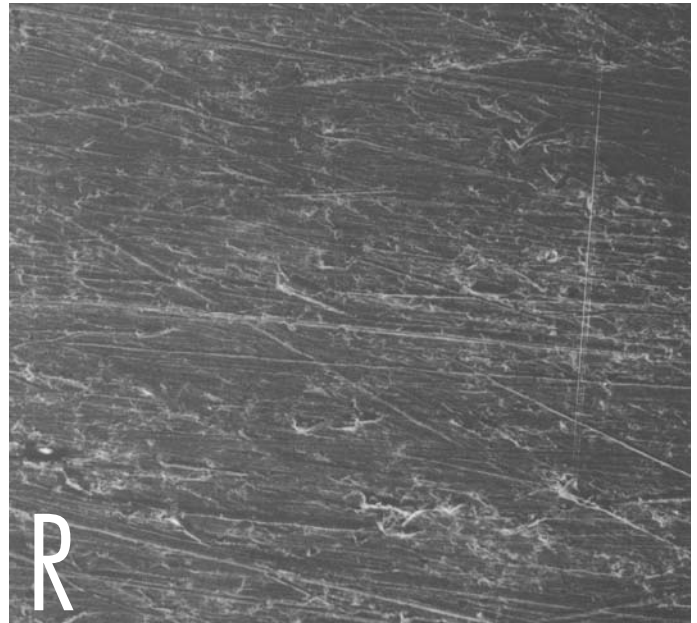
AFTER FLEX-HONE, 180 grit silicon carbide "Q" photo at 1000X, "R" at 100X. Uniform cross-hatch pattern. Surface has clean open appearance with most of torn, folded, and smeared metal removed. Excellent semi - plateaued profile. 20 to 25 μ " (.51 to .63 μ m) finish. #A-6 cylinder.

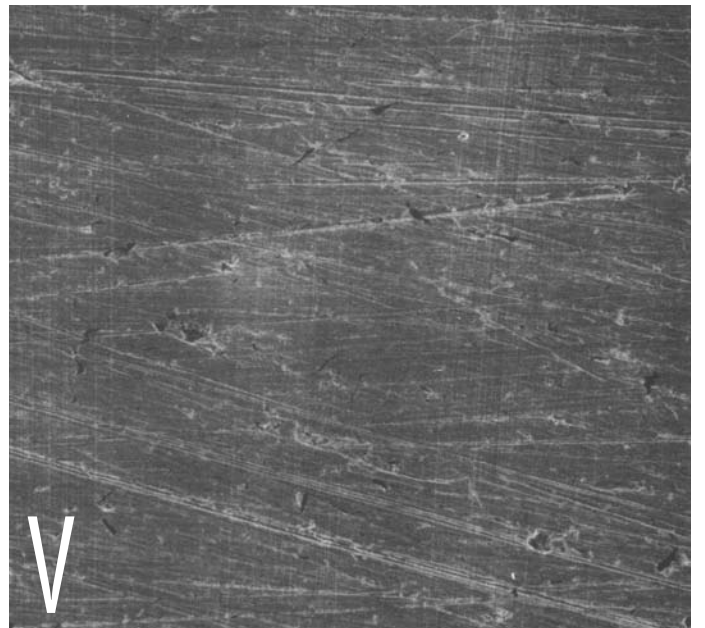
AFTER FLEX-HONE, 320 grit silicon carbide "U" photo at 1000X, "V" at 100X. More refined finish with uniform cross-hatch pattern. Surface has clean open appearance with most of torn, folded, and smeared metal removed. Excellent semi-plateaued profile. 7 to 10 μ " (.18 to .25 μ m) finish. Section of cylinder #A-6.
